ROYAL COMMISSION

QUEBEC BRIDGE INQUIRY

1907

MINUTES OF PROCEEDINGS

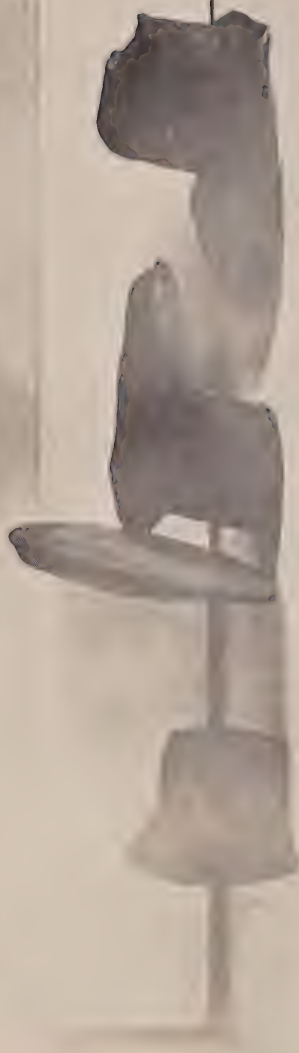
20. Shows a rivet head which has been sheared close under the shoulder and finally flattened by grinding blows. This photograph also exhibits two rivet heads which have been distorted and flattened, and caused to flow over half inch in one direction without shearing. There is also shown on this picture a countersunk rivet which yielded by direct shear.

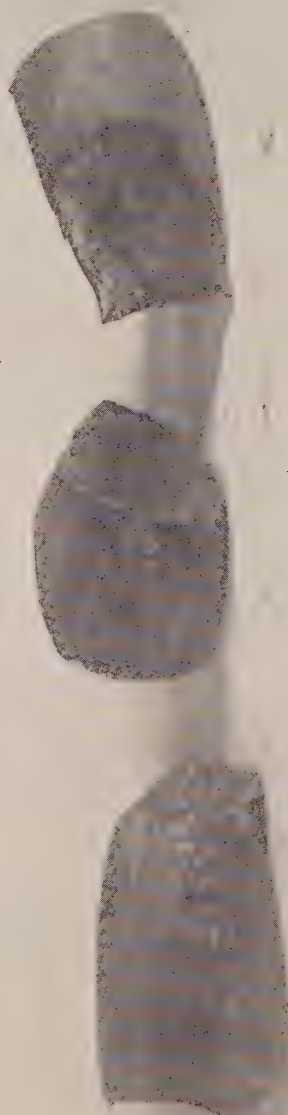
21. Shows fragments of rivet shanks, the centre one being sheared at both ends, the other two being sheared at one end and pulled at the other.

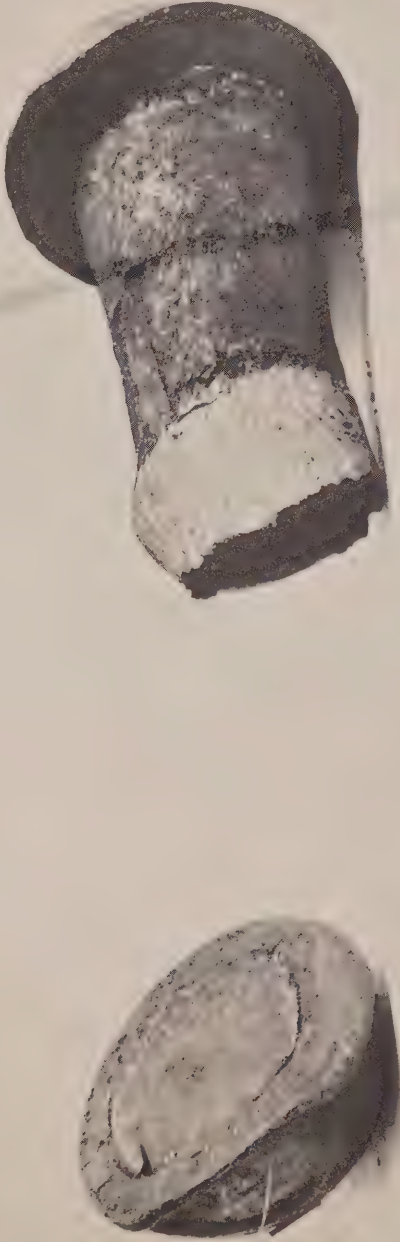
23. Shows a perfect rivet head which has been sheared immediately under the shoulder by a heavy side-blow. It also shows a rivet the shank of which has been pulled out of the head, leaving a ring such as are shown on photograph 18. The rivet specimens shown on photographs 18 to 23 are nearly all $\frac{1}{2}$ inch. A few are one inch. The latter are commonly found destroyed by simple shear, as the type of joint in which they were employed generally produced this action during the disaster.
